SEPTEMBER 2020

BUILDING CONDITION ASSESSMENT REPORT (SUPPORTING MATERIAL FOR TDR/TDP
CERTIFICATION REQUEST)

UNIVERSITY METHODIST EPISCOPAL CHURCH/VINEYARD CHURCH

4142 Brooklyn Ave NE

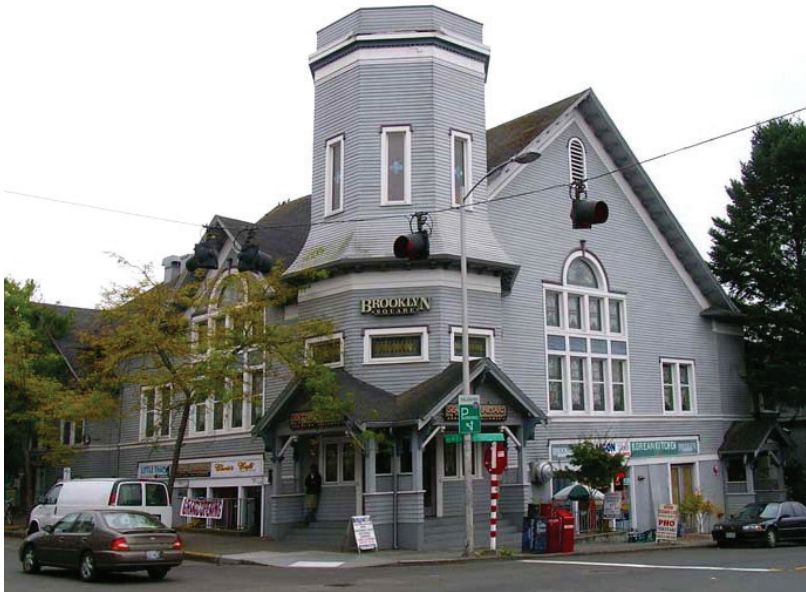
Photo: Historic Seattle, 2011

The paint finish is now green color. Evidence at porches and the main floor indicates this color has been touched-up to cover graffiti and other repairs to the siding. Siding maintenance is scheduled for the Fall of 2020.

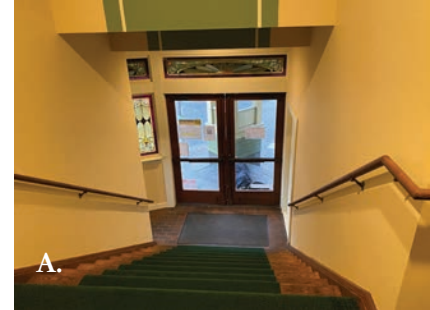
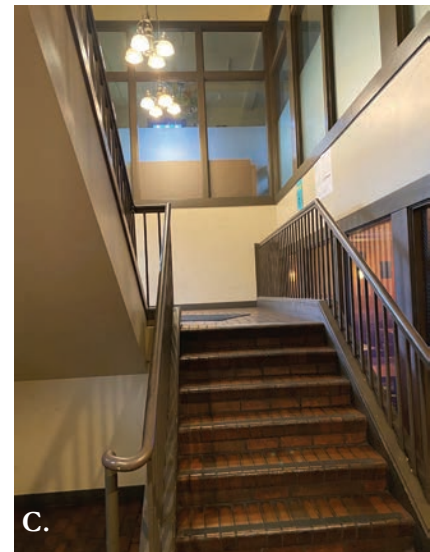
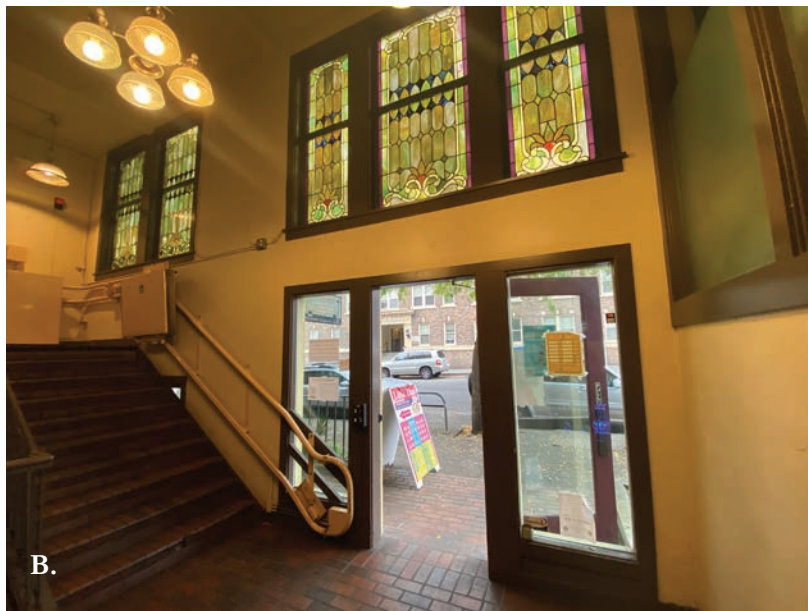
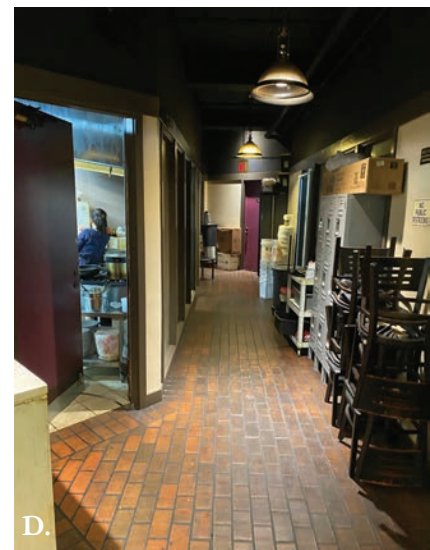
Photos: A. Tower entry viewing north, B. east entry viewing north including non-original doors and rehabilitated stained-glass windows, C. east entry viewing east up stair, D. viewing south at basement hall near restaurants.

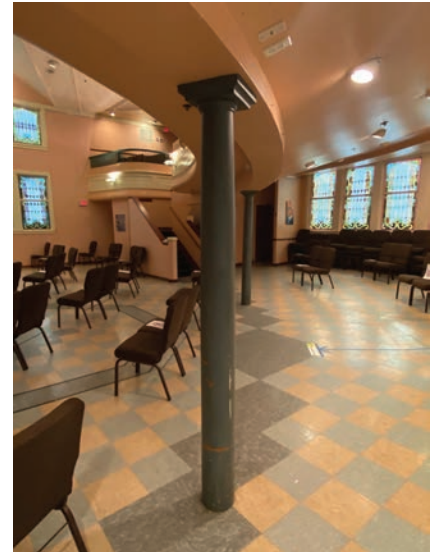
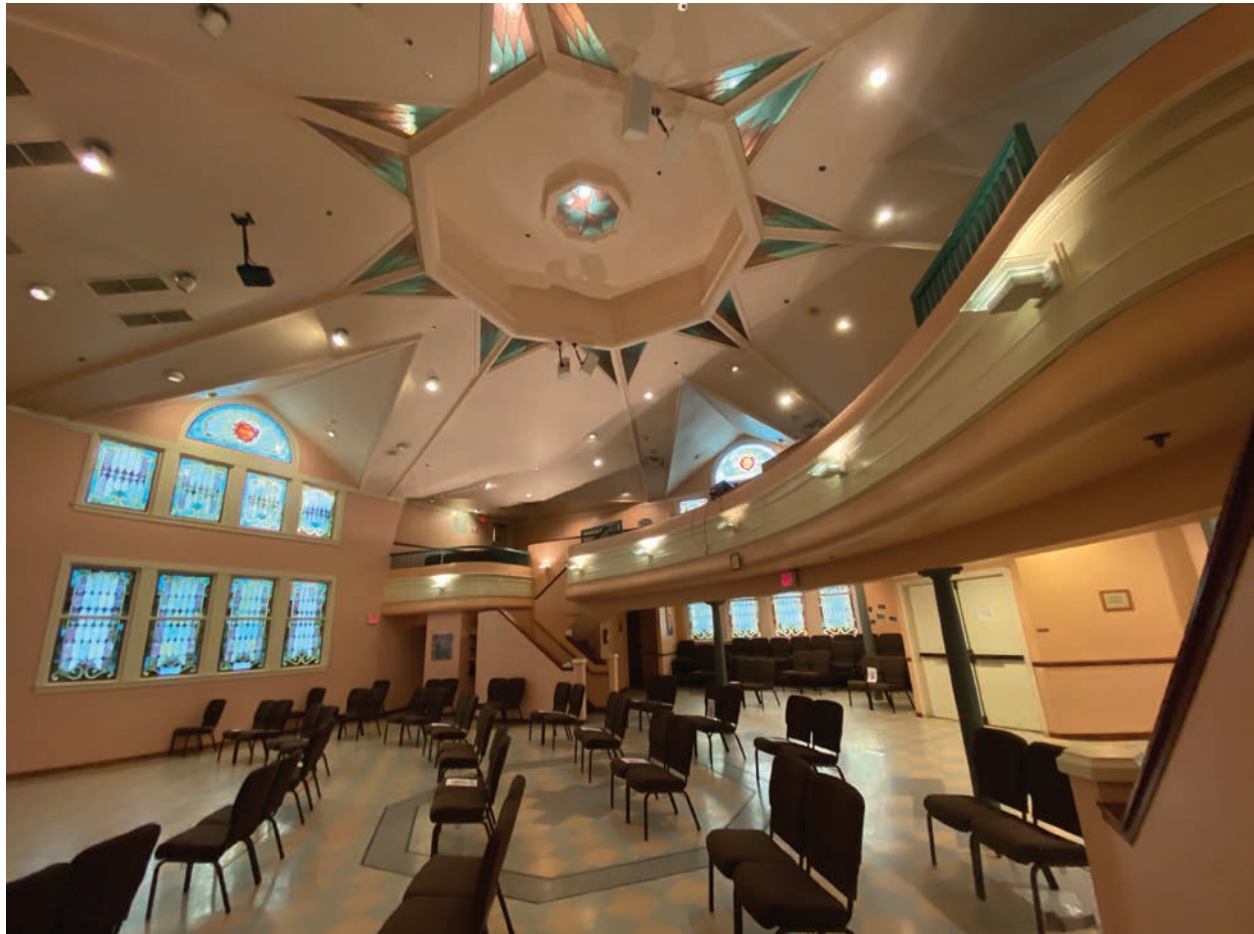
Photos: above view of column supporting mezzanine, below wide angle view of sanctuary veiwng southwest.

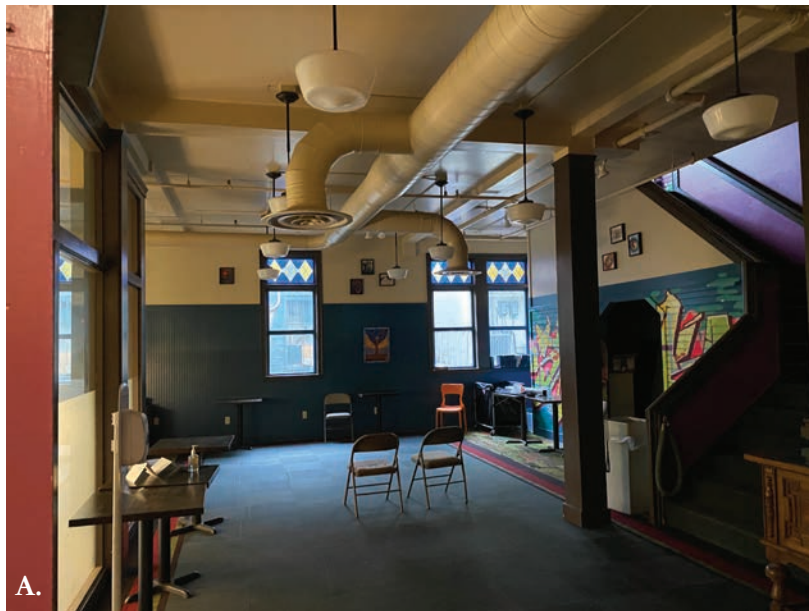
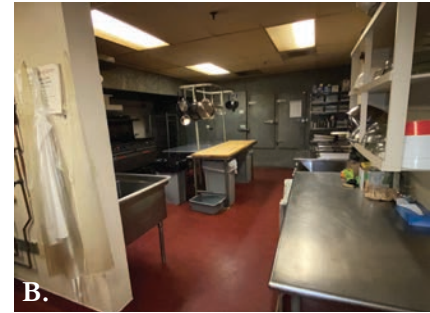
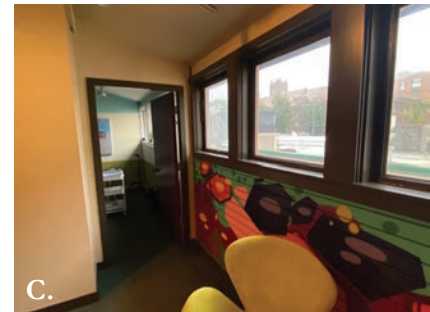
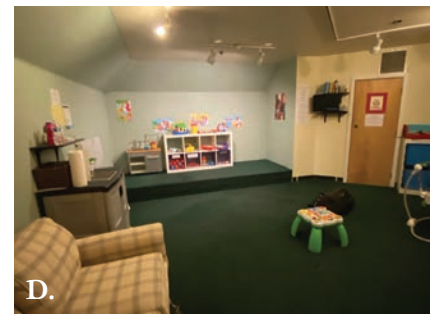
Photos: A. Watershed room, B. Kitchen, C. Church offices at mezzanine, D. children's playroom at mezzanine.
